HOMEOWNER'S HANDBOOK TO PREPARE FOR NATURAL HAZARDS

REPUBLIC OF THE MARSHALL ISLANDS

By
Don Hess
Dennis Hwang
Karl Fellenius
Ian Robertson
Mark Stege
Ben Chutaro

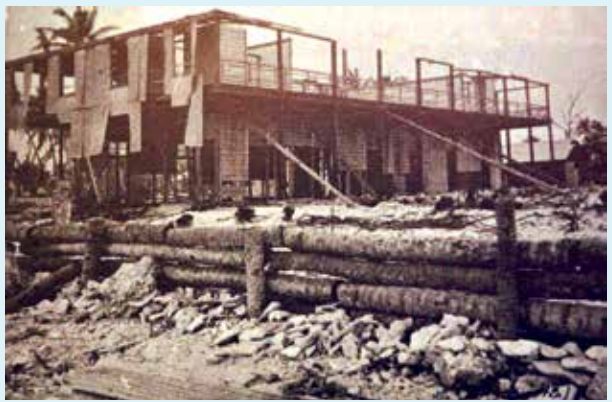
Figure 2-6. Typhoon Wind Impacts - Damage to the Catholic Girl's and Nuns' Living Quarters building in Jaluit after the 1905 typhoon. Note the blown off roof, which is common from the strong winds of a typhoon. In addition, there is water damage or inundation that overtopped the log seawall and eroded or scoured sediment behind the wall (Photo Micronesia Area Research Center).

Blown off roofs from a typhoon demonstrate the need for strong roofs and attachments to the wall and foundation. How to do this is shown in Part 3 for emergency shelters and Part 4 for houses.

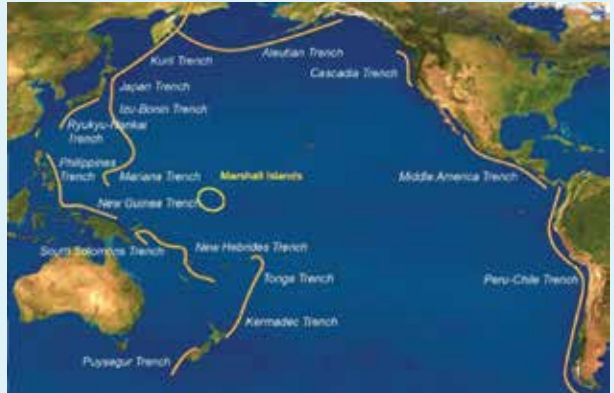
Figure 2-8. Around the Pacific Rim are a series of trench systems marked by orange lines where the ocean floor sinks under the overlying crust. Sudden movement at these trench systems cause subduction zone earthquakes, and if large enough, the generation of a tsunami by the displacement of large volumes of water.

Tsunamis are large surface waves caused by a major disturbance in the ocean such as a submarine earthquake, underwater landslide, volcanic eruption, or meteor impact. By far, the most likely cause for tsunamis in the Pacific will be from an earthquake associated with the major subduction zones around the Pacific Rim known, as the Ring of Fire (see Figure 2-8 and 2-9).

Some major historical tsunamis in the Pacific that impacted the Marshalls include the 1957 tsunami off the Aleutian Trench and the 1960 tsunami off the Peru-Chile Trench (see Figure 2-8 for the source/location of these events). Measured inundation depths were 10-13 feet (NOAA, 2011). Modeling of earthquakes from the Kuril, Mariana, and Ryukyu trenches estimate overland flow of 3-6 feet (see Robertson, 2015).

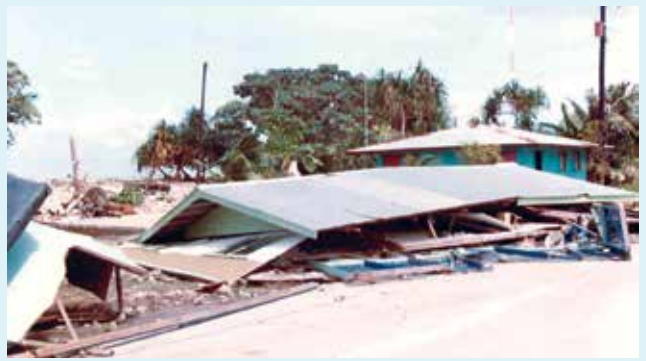
Figure 2-13. During the 1979 inundation event, there were 100 to 300 houses that were destroyed. Many more were damaged. Wave inundation such as this is the reason elevating houses is covered in Part 4 of this book in order to reduce the risk of damage. Photo courtesy of Hamilton Library, University of Hawai'i Pacific Collection.

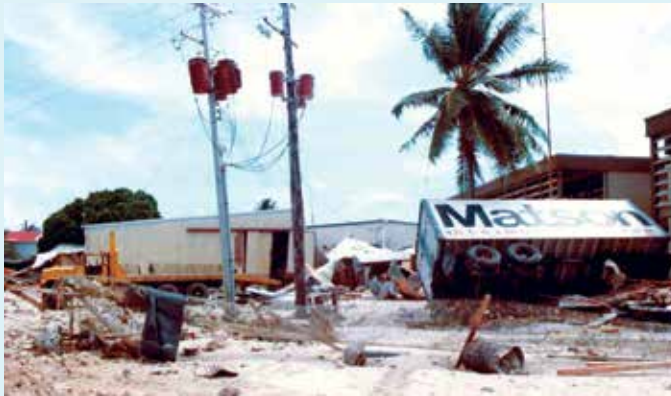
Figure 2-14. During the 1979 event, there was an estimated \$26 million in property damage and major portions Djarrit and Delap were covered in sediment. Photo courtesy of Hamilton Library, University of Hawai'i Pacific Collection.

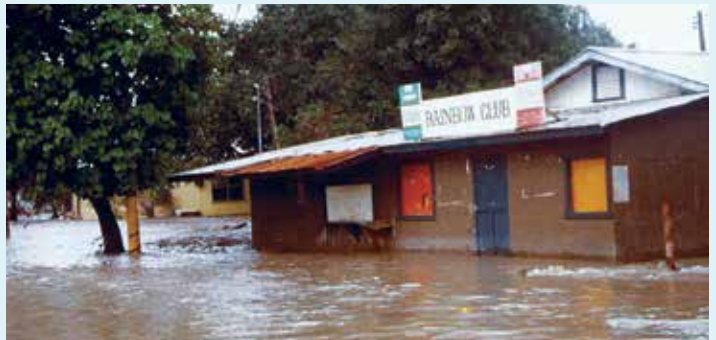
Figure 2-15. Also during the 1979 event, over 5,000 people lost use of their homes due to flooding (Hoeke et al., 2013). Photo courtesy of Hamilton Library, University of Hawai'i Pacific Collection.

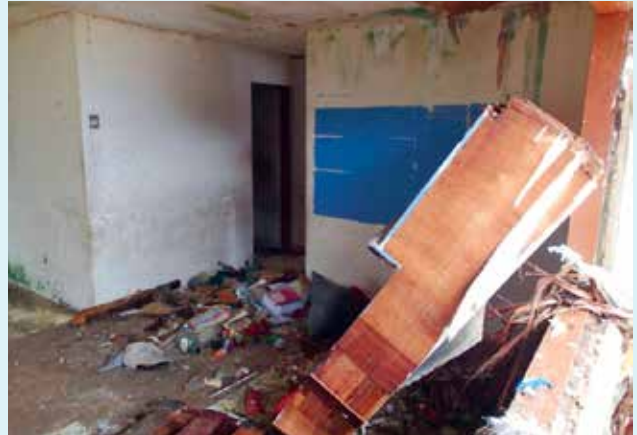
Figure 2-17. During the March 2014 event, about 110 homes were damaged and about 940 family members were displaced and sought sanctuary in government-designated shelters and churches. It is because of damage such as this that Part 4 of the handbook covers tools to reduce damage such as elevating of structures or building with flood resistant materials.

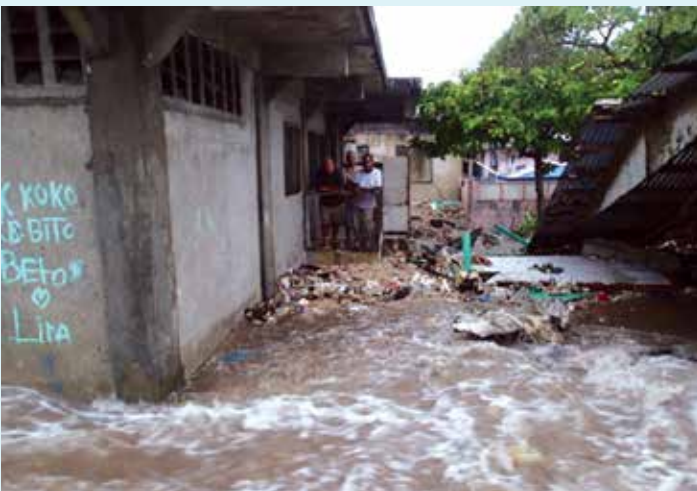
Figure 2-18. Even if a structure is elevated or built with flood resistant materials, during a typhoon or major tsunami, shelter should be to structurally sound buildings such as covered in Part 3 of this book. It may be acceptable to shelter in place for smaller events, such as the March 2014 floods, however, it is more than likely that inundation will be unpredictable (larger or smaller than anticipated). Thus if in doubt, evacuate to designated shelters.

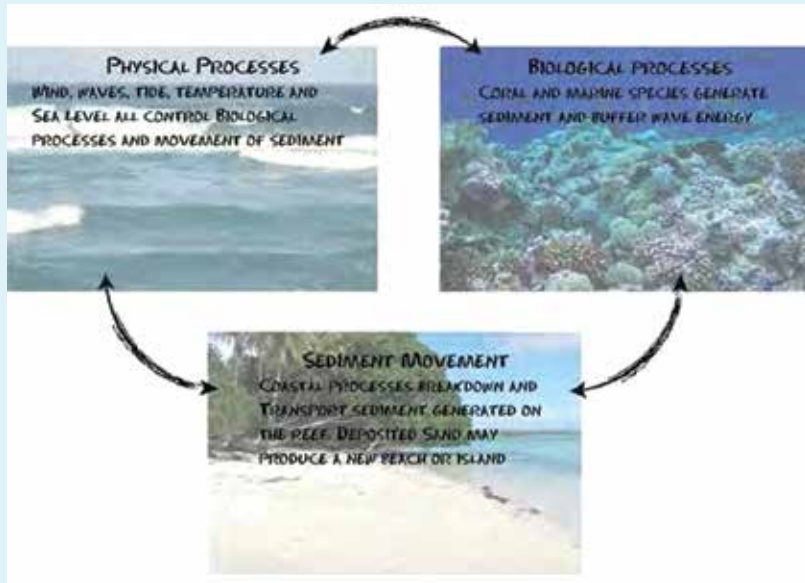
Figure 2-24. Some physical coastal processes include wind, waves, currents, tides, temperature, and sea level. They continually drive the sediment produced via biological processes and result in sediment movement that builds and erodes islands. Marine deposition on geological timescales and terrestrial deposition from episodic flooding are the overriding large-scale processes that determine where sediment accumulates over time.

Coral reef islands are naturally dynamic features, with their shoreline moving as a result of changes to the physical and biological environment. Reef islands are made up of sediment that is generated by the breakdown of living material on the adjacent reef. Coastal processes are physical and biological mechanisms that operate along a coastline, bringing about various combinations of sediment transport, erosion, and deposition. Human use of Majuro requires space and produces waste, which affects these natural processes and changes the location and relative proportions of erosion and accretion that would otherwise be present if it was an unpopulated area. Physical and biological processes are involved whether a coastline is eroding or accreting (Figure 2-24).

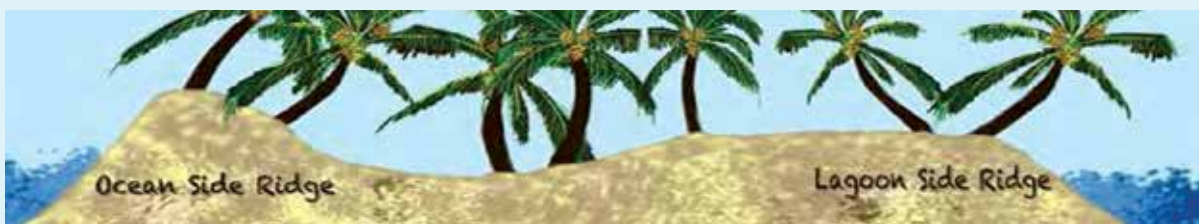
Figure 2-25. The ridges of an atoll serve the important function of protecting inland areas from wave inundation and flooding. Thus they should be maintained and enhanced if possible.

Tides allow higher waves to reach the island at high tide. Island morphology shows that the highest elevation of an atoll island is on the ocean side berm (ridge), which is made up of coarse coral sediment and larger shingles (Figure 2-25). Lagoon shorelines are exposed to smaller waves, resulting in smaller berms made up of fine sediment.

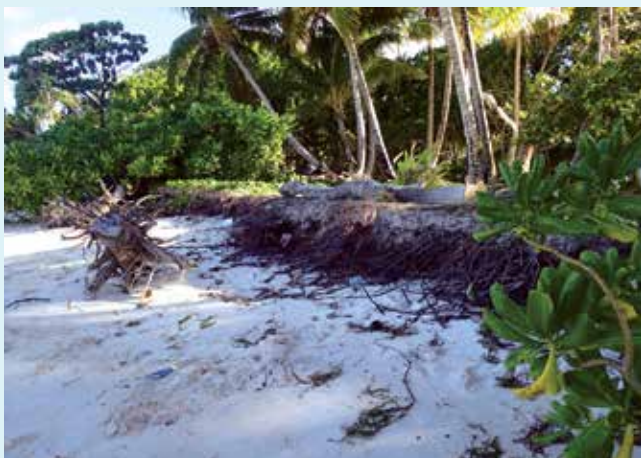
Figure 2-26. Erosion of the coastline at Laura, Majuro. Erosion is a serious hazard as it causes the shoreline to move inland and thus makes houses and buildings at increased risk from wave inundation and flooding. Erosion can be caused by physical processes associated with a tropical cyclone, tsunami, extratropical storm, and/or sea-level rise.

Erosion - When more sediment leaves a shoreline area by physical processes than is deposited by biological and physical processes, than erosion of the coastline occurs. This is typically seen by retreat of the shoreline and a vertical cut in the vegetated dune (Figure 2-26).

The biological processes on Majuro's reef are significantly degraded due to the developed shorelines and nearshore herbivore fishing pressure in proximity to the urban center. Therefore, physical processes are likely more eroding rather than depositing sediment from biological processes over time (Figure 2-26). Coastal protection services from the ecosystem are slowly diminishing via bioerosion. Nutrient loading from run-off and sewage discharge is the primary local point source cause for the reduced ability of the reef to calcify as it becomes more algae-dominated than coral.

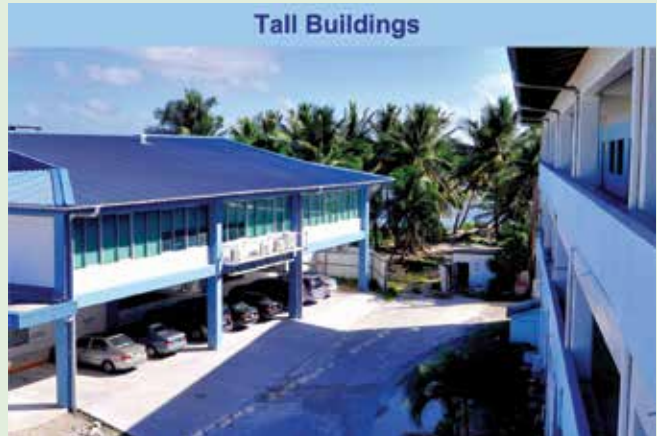
Figure 3-2. For a strong tsunami or typhoon, evacuation to buildings with two floors or more is required. All things being equal, the taller the building the better. This photo taken from the third floor of the Assumption School (right) is of the two floor Administration Building for the College of the Marshall Islands (left). Both buildings are considered shelters for only the second floor or above.

Because of the low elevation in the Marshall Islands, a shelter must be a tall building with two floors or more (Figure 3-2).

Criteria	Comments	✓
1. Tall building	Use second floor or higher. The taller the building the better if in good condition (Figure 3-2).	
2. Reinforced concrete	Best – Beam-column moment frame with open lower floor (Figure 3-3); Good – Moment frame with CMU infill on first and second floors (Figure 3-4); Acceptable – CMU walls – (solid grouted – concrete and rebar fill the holes) and under 20 years old (Figure 3-5).

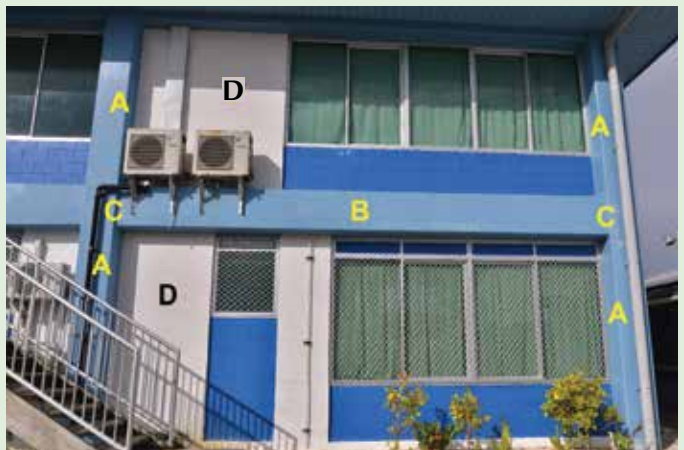
Figure 3-4. Many buildings identified as shelters have the Concrete Moment Frame – with columns (A), beams (B), and column-beam joints (C). They also have CMU blocks on the 1st and 2nd floors as infill (D) (see also Figure 4-39). While it is preferable that the first floor be open air as in Figure 3-3, this is still a strong structure if well maintained. This is the College Center at the CMI.

Examples of strong buildings with a Concrete Moment Frame and Concrete Masonry Unit (CMU) block infill are at the CMI (Administration Building, Learning Center and College Center only) (Figure 3-4), Rita Elementary School and the Marshall Islands High School. Many buildings in Majuro, including many residential houses are built with this design (see Part 4 of this book - Figures 4-1 to 4-3). However, houses cannot be used for shelter for a strong tsunami or typhoon because they lack elevation.

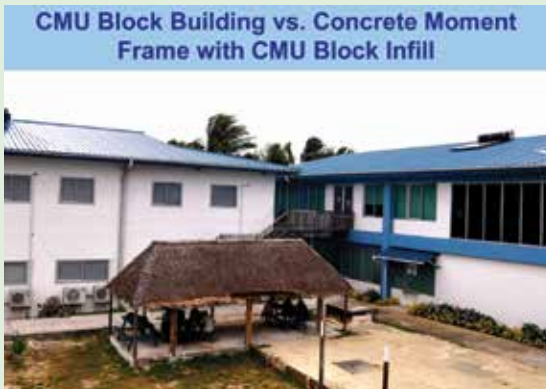
Figure 3-5. The building on the right has a Concrete Moment Frame as shown by the blue columns and beams and CMU block infill (Administration Building at CMI). Compare that with the building on the left with only CMU blocks (Tole Mour Hall at CMI). The building on the right is stronger because of the Concrete Moment Frame.

There are also buildings in the Marshall Islands with no Concrete Moment Frame and are CMU block infill (Figure 3-5).

Examples of buildings with just CMU block are Tole Mour Hall, Wapepe Hall, Debrum Hall and Rebbelip Hall at CMI (Figure 3-5). These buildings can be used as a shelter if well maintained although they are not as strong as the Administration and Student Center Buildings.

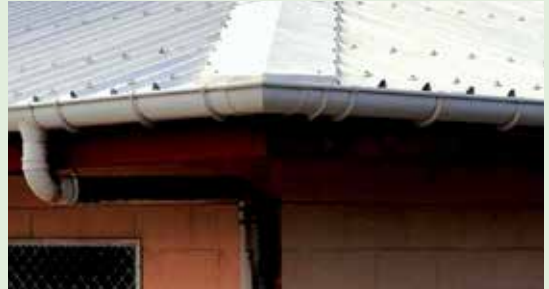
Figure 3-6. Marshall Islands High School has many of the criteria looked for in a shelter. Note corrugated metal roof with sufficient fasteners and large washers to hold the metal roofing down during high wind events. The fasteners should be ring-shank nails or screws that are well-embedded into the supporting roof trusses, rafters, or purlins.

winds during a typhoon. The structural factors required for a sound roof are: good condition roofing that is well attached to the roof framing members (Figure 3-6); strong roof trusses (Figure 3-7) or roof beams (Figure 3-8); and a strong connection of the roof framing to the supporting columns, beams, or walls of the building (Figure 3-9).

3. Tie down roofing	Secure roofing material to the roof (usually plywood over the trusses or rafters) with sufficient number of fasteners and large washers (Figure 3-6).

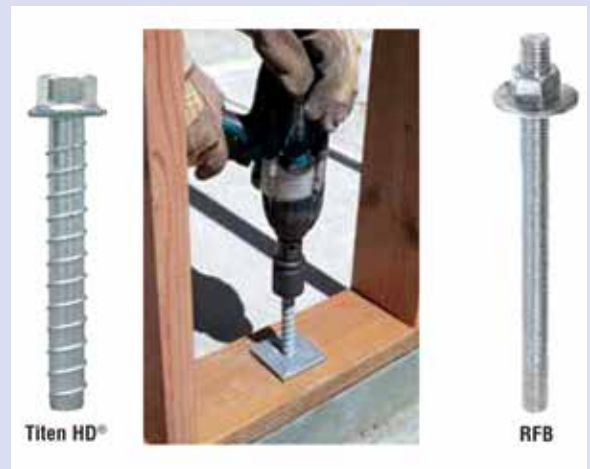
Figure 4-5. For retrofit of existing structures, where a strong connection between the wood top plate and concrete structural bond beam is needed, sill plate anchors such as on page 42 of the SWCCC can be used. Bearing plates can also be used. This retrofit requires sufficient access under the roof. A right angled impact driver may be needed. For the screw on the left (Titen HD), pre-drill the hole to the size of the shaft, with a hammer drill using a concrete bit. Then screw in with an impact drill. For the fastener to the right, drill with a 1/8 inch oversized hole, then fill in with structural epoxy.

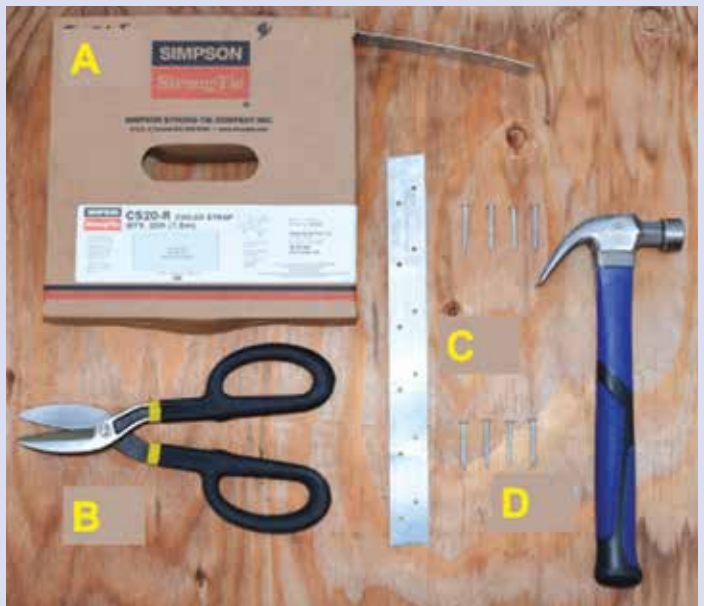
Figure 4-14. Attaching roof members to the beam with galvanized metal straps. (A) Structural straps in a coil and with different lengths and thickness are available locally. (B) The strap is cut to the desired length with a metal snippet. (C) Metal strap cut to desired length. (D) Six 10d or seven 8d common nails can be used to attach each end (page 189). The length is cut as needed, or the table in SWCCC can be followed for specific design loads. This is a general purpose connector for members that are flush. For those at right angles to each other, bends may be needed, and thus other connectors may be more useful. The advantage of the coiled straps is low cost and the flexibility to adjust the length. CS-16 straps are available in Majuro at a cost of \$138 for a coil of 150 feet.

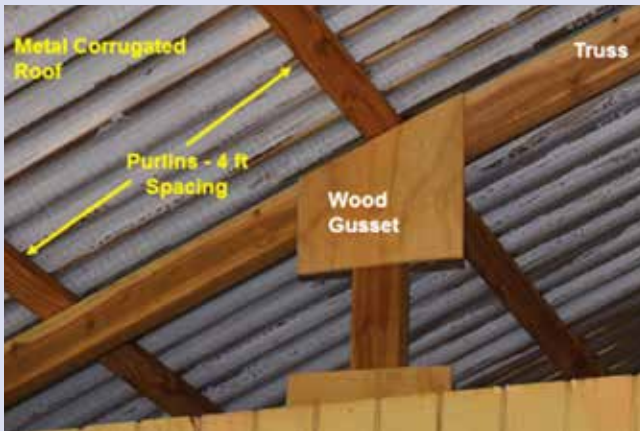
Figure 4-15. Typical roof structure can be strengthened for new construction and in retrofit applications. To tie the roof trusses, sometimes nails are used in tension, which pull out easily in high winds. Stronger is the use of wood gussets, instead of nails to tie the truss together in shear. Note the purlins are spaced 4 feet apart. If the purlins were 2 feet apart the roof would be stronger.

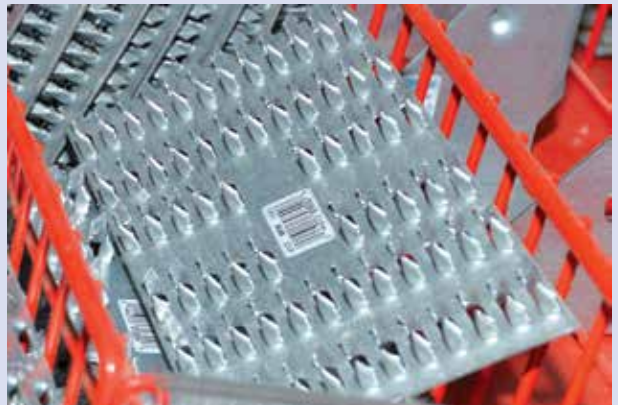
Figure 4-16. Strong truss connections come from the use of metal plates or wood gussets. Both the metal plates and/or wood gussets can be used for new construction or could be used for retrofit applications if the roof structure is not covered by a ceiling. Mending plates are readily available at the hardware stores in Majuro. They come in different sizes so make sure they are designed for trusses.

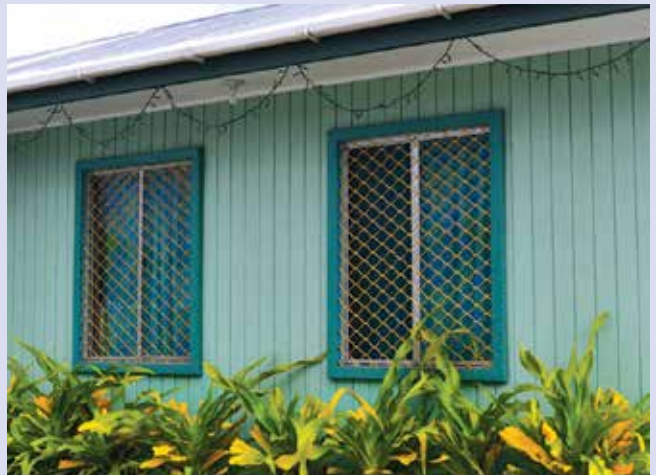
Figure 4-34. Many schools in Majuro and a few houses have security screening. The advantage of the screening is that it is always on the window. The disadvantage is that small stones or debris can still penetrate the screening if the holes are sufficiently large and break the window, thus allowing in rain and wind. Security screens need to be securely fastened to the framing of the windows.

If the homeowner does not want to prepare and store plywood, another option is security screening, which can serve the dual purpose of providing security, while preventing breakage of windows from flying debris (see Figures 4-34 and 4-35).

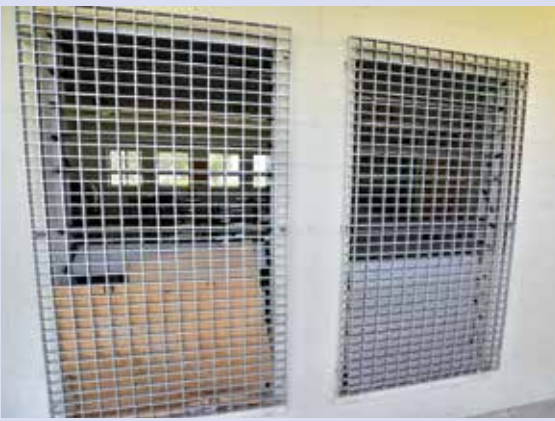
Figure 4-35. Another option for window protection is this aluminum security screen seen on a few schools such as Marshall Islands Middle School. The screen allows in light, and the openings are sufficiently small to stop most debris. The framing is bolted into the concrete masonry unit wall. While stronger than the screen in Figure 4-34, it is also more expensive. This is good window protection for houses with CMU walls (see Figure 4-1).

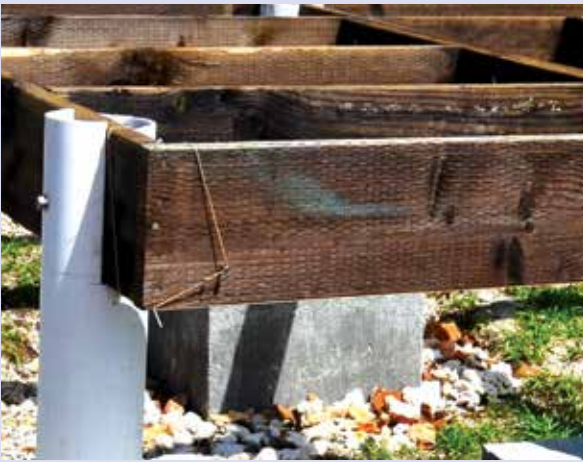
Figure 4-36. Example of ACZA wood suitable for use in the marine environment. Note the cuts or incisions on the surface to increase penetration of the chemical treatment. Because the chemicals in this wood are very corrosive, as well as the marine environment itself, stainless steel fasteners are used to attach the column to the wood joists (support for the flooring). Photo courtesy of Ben Chutarro.

Ammoniacal Copper Zinc Arsenate (ACZA) Wood. Generally wood with arsenic has been phased out of residential construction. However, it can be found for commercial settings and exterior use. ACZA is resistant to leaching and thus suitable for waterborne systems (Figure 4-36). It is very resistant to termites, but also very corrosive. It is suitable for the treatment of hard woods such as Douglas Fir.

Figure 4-44. Better than treated wood in the ground (Figure 4-38), or a wood column with concrete spread footing (Figures 4-42 and 4-43), is the use of 6 inch PVC pipe extending to the base of the concrete spread footing. The PVC is reinforced with epoxy coated rebar that extends 6 feet below the surface. The rebar is also placed every 6 inches in a horizontal crisscross pattern through holes drilled in the PVC pipe. Concrete is then poured into the PVC. The only wood is 3.5 feet off the ground and is ground contact, termite treated ACZA Douglas Fir (Figure 4-36).

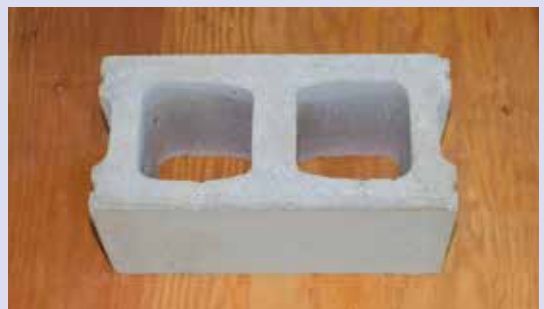
Figure 4-39. CMU blocks are the building blocks for many houses, commercial and government buildings in the Marshall Islands. Sometimes, the holes are left empty, and then the CMU is ungrouted. Other times they add rebar and concrete in the two holes making the CMU grouted and reinforced. Whether grouted or not, CMU blocks are a highly flood resistant material.

Concrete Blocks - Concrete Masonry Unit (CMU) blocks can be used for walls (Figure 4-39).

Figure 4-45. This design by the Ministry of Public Works in Majuro elevates the structure 3 feet off the ground on concrete masonry blocks (Figure 4-39). Grouting and rebar can be added to the CMU for added strength. The simple design is the cheapest and can reduce flood risk for small frequent events.

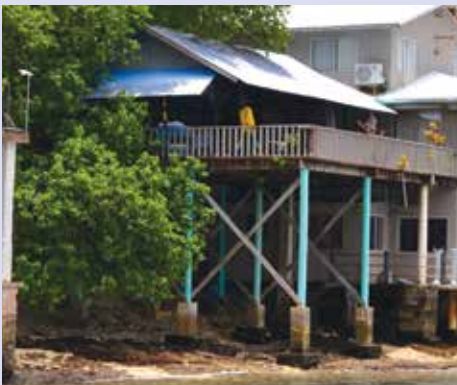
Figure 4-40. This house in Majuro was elevated to prevent damage from wave inundation and flooding. This is an extreme example of elevation of structures. Many houses in Majuro have been elevated a more modest amount (see Figure 4-41). This house has a spread concrete footing (see Figure 4-42). The brown wood members forming the X pattern are cross bracing to provide additional lateral support of the structure.

In Majuro, houses have been elevated from a few feet to over 10 feet to avoid flood and wave inundation damage. (Figures 4-40 and 4-41). Elevation is a time tested effective way to prevent property damage from coastal hazards **if designed and planned for properly**. The practice of elevation is an option for new houses and is generally not feasible for existing structures. Because it is primarily for new houses, only a few design suggestions are in this section for consideration by homeowners and government officials contemplating the more formal use of this option.

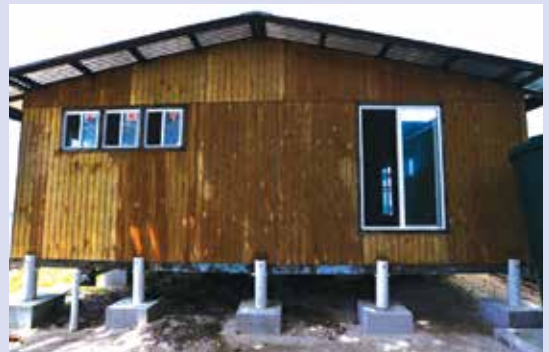
Figure 4-41. Another house in Majuro was elevated about 3 feet above grade. A spread concrete footing (Figure 4-42) was utilized with concrete piers encased in PVC pipe. The piers extend into the footing and are reinforced with epoxy coated rebar. Photo courtesy of Ben Chutaró.

Compare the houses in Figures 4-41, 4-45, and 4-48. These are just three different designs. But there are many ways to elevate a structure (see also Figure 4-38). Note with increased strength, comes increased costs. These are the tradeoffs. Someone building a new home can choose from the different designs, depending on their budget. Modification of the different designs is also possible to make them stronger and more expensive or cheaper. For example, it is possible to build the CMU piers in Figure 4-45 with epoxy coated rebar (Figure 4-47), grout the CMU (Figure 4-39), and bury the piers (Figure 4-42), which would add cost but be stronger. It is possible to build the house in Figure 4-41 higher, with wider piers, or ones that are more closely spaced, also adding strength and cost. Conversely, it is possible to reduce cost in Figure 4-48 by making a smaller, less elaborate structure. Thus there are many design variations of the three options provided, as well as other design concepts which are not covered in detail because the major emphasis of this book is retrofit of existing structures versus the design of new structures.

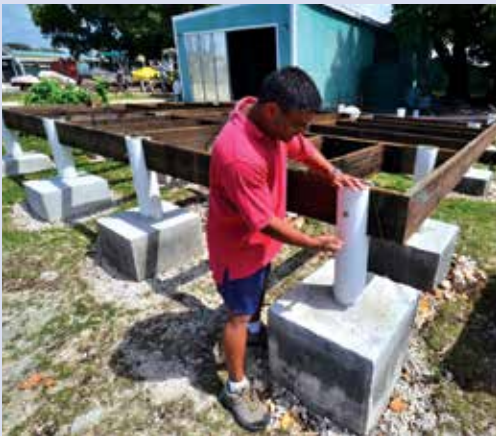
Figure 4-43. Example of steel straps with column base available in Majuro that can be used to connect a concrete spread footing with wood columns. The wood and concrete should not be in contact because the sweating of concrete can cause wood rot. The strap provides separation between the two incompatible materials. An experienced coastal engineer or architect should be consulted to design the footing and columns, if available.

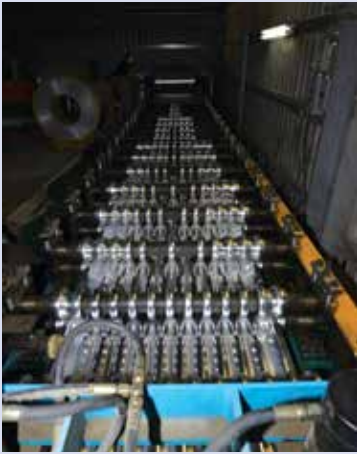
Figure 4-51. An aluminum press and cutting sheet in Majuro can make metal corrugated roof and gutters of different dimensions. This can help to ensure proper overlap of aluminum roofing sheets (two ridges of overlap – see Figure 4-23). In addition, aluminum gutters can be created that are 4, 5, or 6 inches in width. The larger gutter width will maximize water capture during a rain event.

store can possibly order a larger width. Alternatively, aluminum gutters can be bought in Majuro that are custom made with different widths (Figure 4-51). If different widths are used, make sure the fasteners are increased to account for the added weight of the gutter.

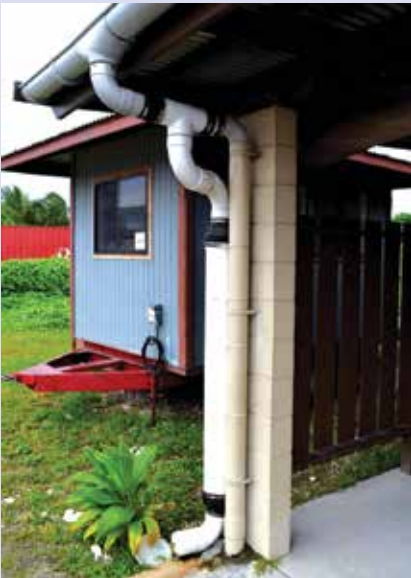
Figure 4-54. First-flush systems can be ordered or they are easy to create yourself. Ask your local hardware store if you have any questions about materials or how to build one. The systems are sized for the size of the roof. As a general rule, and from existing literature, the diversion pipe must catch 5-10 gallons of water per 1,000 square feet of roof area (see University of Hawai‘i Mānoa pamphlet and website). See Table 4-5 to see the relationship between first flush diverter pipe diameter width, length and amount of water to collect.

Sample Sizing – A house has a roof area of 50 feet by 40 feet to collect water or 2,000 square feet (50 feet * 40 feet =2,000 feet²). Therefore the first flush system should collect 10-20 gallons of water.
