Hurricane Ida – Damage Typologies Resilient Repair, Retrofit, Rebuild & Recode Version 1.0

Introduction

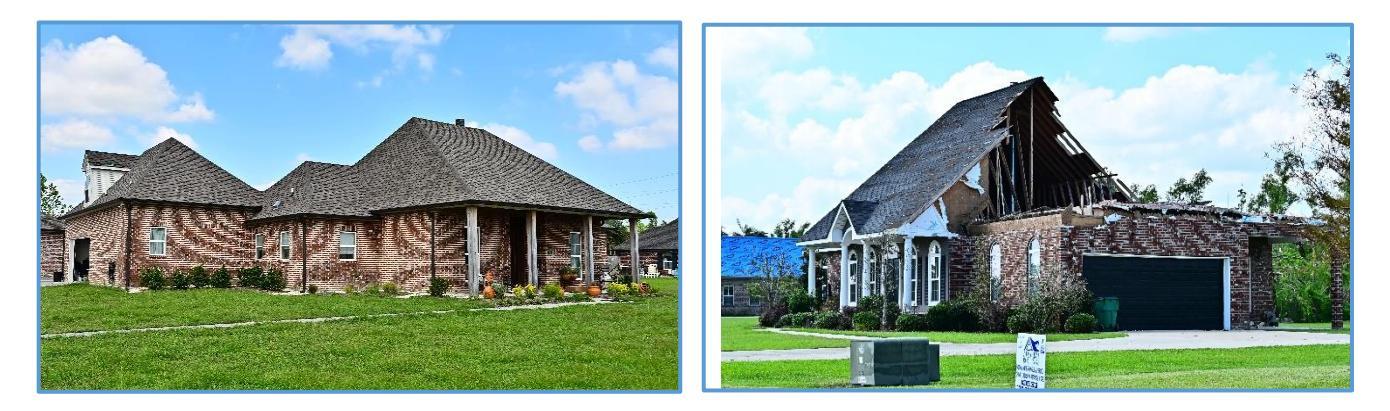
Two houses at the same block in St. Charles Parish. The house on the left is two years old with a hip or cross-hip style roof. Uplift pressure on the roof is reduced due to wind creating downward pressure on the sloping faces. The house on right was built 8-10 years ago with a large gable end. The disadvantage of this design is the large forces on the wall during hurricane events can collapse the gable end, pushing the wall in or out. The advantage of a gable end is lower costs, and greater space utilization for both the interior and on the exterior (e.g., if solar panels are added). For any new houses subject to future high winds, the hip style roof should be the preferred choice.

This report is for those that want to repair their structure and for those that may need to rebuild. Generally, houses with hip style roofs did better than houses with gable end roofs. Two examples are given for houses in the same area. This is not to say that no hip style roofs suffered any damage, as some did. Performance would be a function of roof shape, location relative to the wind field, strength of framing (bracing and internal connectors), workmanship and other factors which the field work did not allow complete analysis. However, roof shape is definitely an important factor and when it is possible to build without large gable ends, performance during a hurricane should be an important factor.

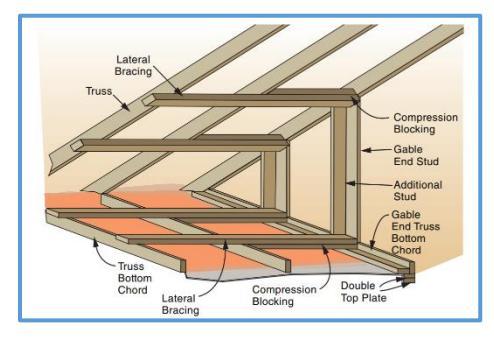
This is a typical gable end wall bracing example found in the FEMA Home Builder's Guide to Coastal Construction – P-499 Technical Fact Sheet 9.2. Also, the IBHS video referenced below, a similar method is demonstrated step by step. One difference between the two methods is the compression block is above the lower lateral brace instead of below. This may facilitate installation.

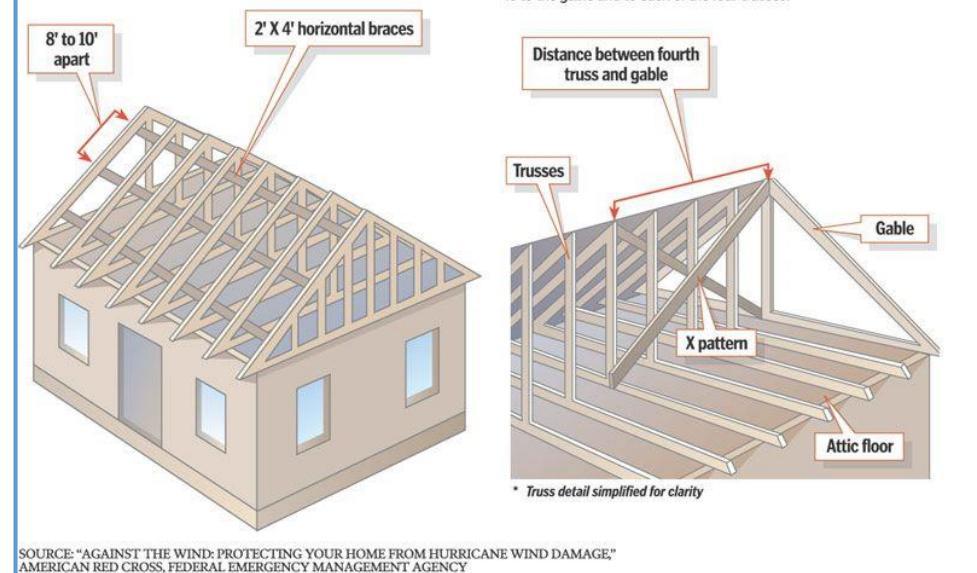
Place 2-by-4s in an X pattern from the top center of the gable to the bottom center brace of the fourth truss, and from the bottom center of the gable to the top center brace of the fourth truss (see figure). Use two 3-inch, 14-gauge wood screws or two 16-penny galvanized common nails to attach the 2-by-4s to the gable and to each of the four trusses.

In gabled roofs, truss bracing usually consists of 2-by-4s that run the length of the roof. Braces should be installed 18 inches from the ridge in the center span, and from the base, with 8 to 10 feet between braces. Use 3-inch, 14-foot gauge wood screws or two 16-penny galvanized common nails at each truss.

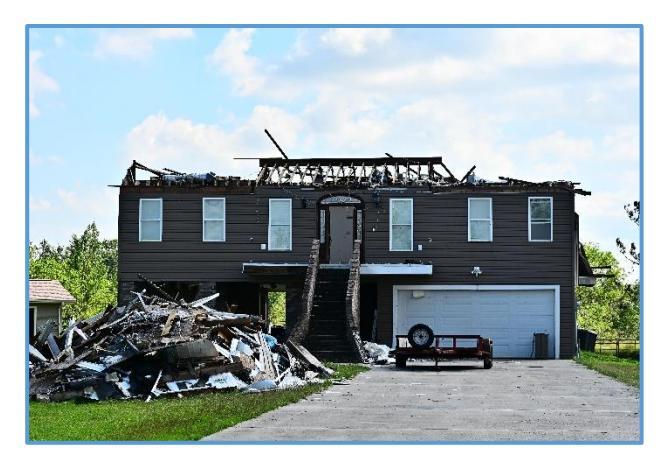
The continuous load path connection ties the roof to the walls and the walls to the foundation. Each intersection has a specified connector. As mentioned above the roof to wall is vital to keep the roof on, and the house above either did not have the connection, or the connection was not strong enough. Older houses built without the benefit of modern building codes will not have a complete load path. For these houses, it is important to add as much as possible as a retrofit starting from the top down. This differs from new construction where the load path is added from the bottom up.

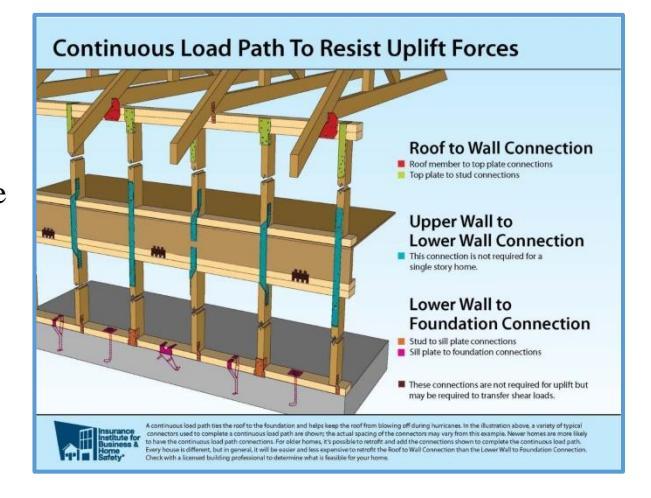
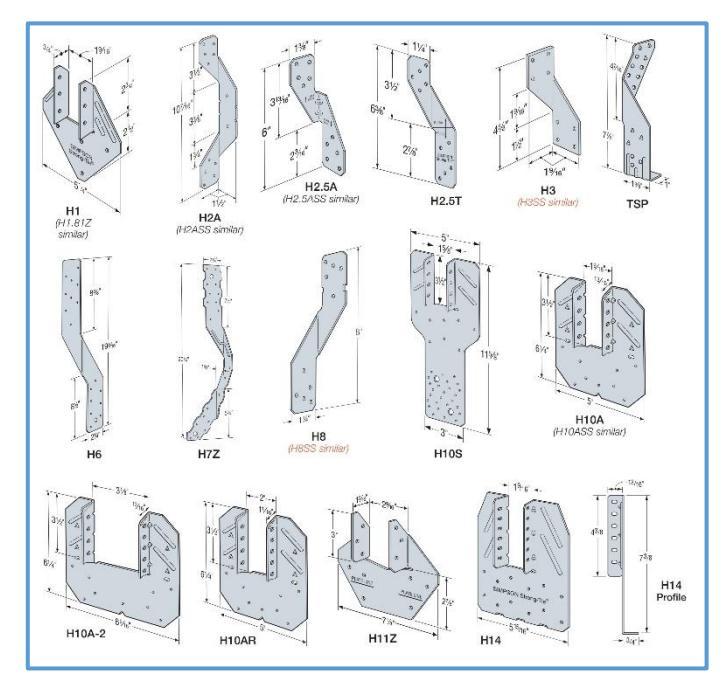
At left, it can be seen there are different types of roof to wall connections with some providing twice as much uplift protection (e.g., H2.5A vs. H10A). Consult with a licensed structural engineer or architect to make sure that the roof is strongly attached to the walls. This will require selecting the proper connector in terms of strength and configuration, given how the house is built. This is most easily done during new construction, and possibly during a retrofit or repair. Each house will be different. Code requirements may govern for new construction or the repair of existing structures. For retrofits that do not need to meet new code requirements,

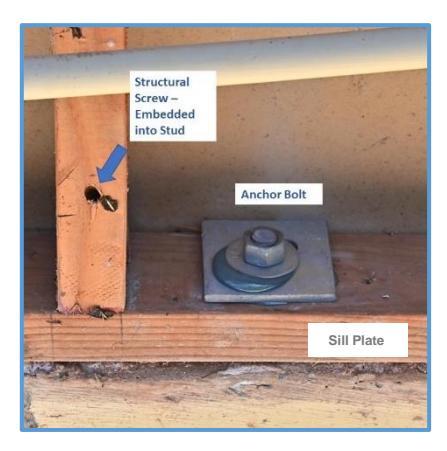
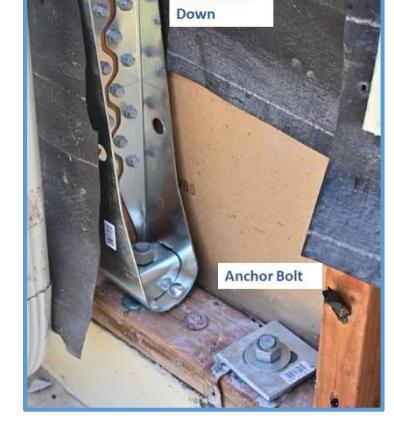
At left, the bottom two rows of fiber cement siding were removed from the house and the following added: (i) anchor bolts to tie the sill plate to the concrete foundation, and (ii) structural screws to tie the studs to the sill plate. At right, an HDU5 Hold Down ties the stud to the sill plate to the foundation and another anchor bolt ties the sill plate to the foundation. After the

retrofit, the fiber cement siding is attached with new sheets and painted so that there is no indication of any retrofit or repair.

Once at the sill plate, it may be possible to remove the bottom two rows of siding and add holddowns and anchor bolts as a retrofit, completing the load path for older houses built without the benefit of modern building codes. It is also possible to add connectors that are stronger than required under applicable building codes.

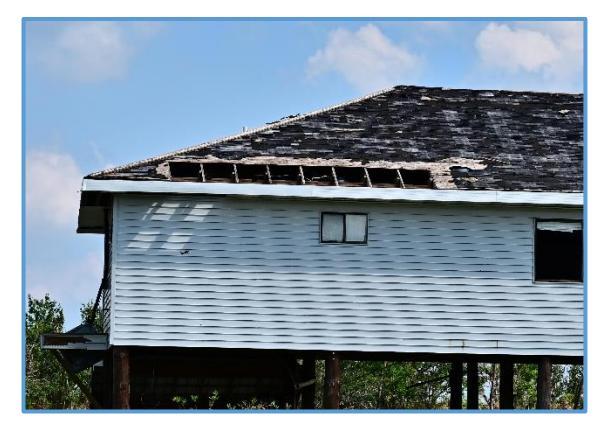
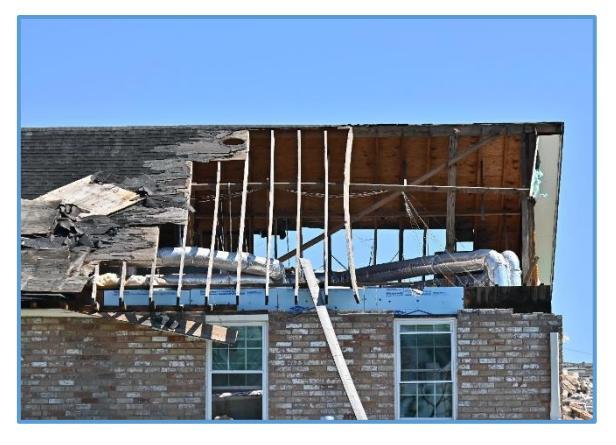
This can be for new roofs and repair of existing roofs, after all the shingles have been removed.

Typical attachment to the roof deck uses smooth shank nails, which have no ridges or threads on the nail. A stronger way to attach the plywood sheathing/roof deck is with ring shank nails, or screw shank nails. See the Table below. These are optional methods of attachment, designed to give the consumer more choice, with the trade-off being time and cost vs. strength. For proactive homeowners, the option of building as strong as possible should have some appeal, considering the cost and inconvenience of recovering from severe wind damage.

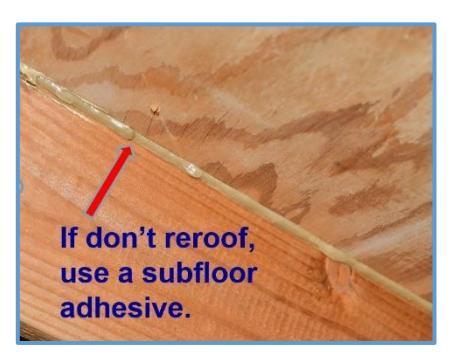
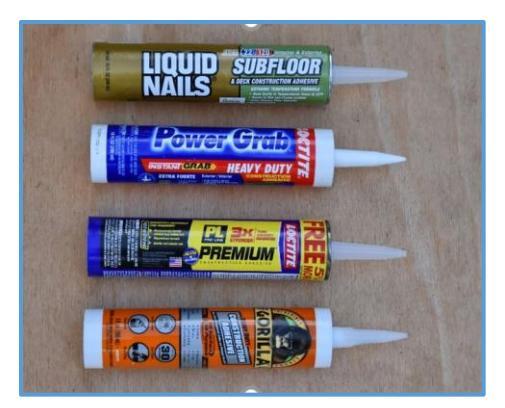
It is possible to fortify the plywood sheathing roof deck by climbing into the attic and applying a quarter inch bead of subfloor adhesive to each side of the roof deck/truss intersection. This can be time consuming and a semi-difficult installation for a homeowner. It may be best to hire a licensed roofer and concentrate at the corners and roof edges first, where wind pressures are the greatest.

The Florida Disaster Organization website and FLASH recommend using a subfloor adhesive meeting AFG-01 standards. Here are examples of adhesives meeting those standards and they can be readily found at the hardware store. For more information on this method, see the links to their websites below.

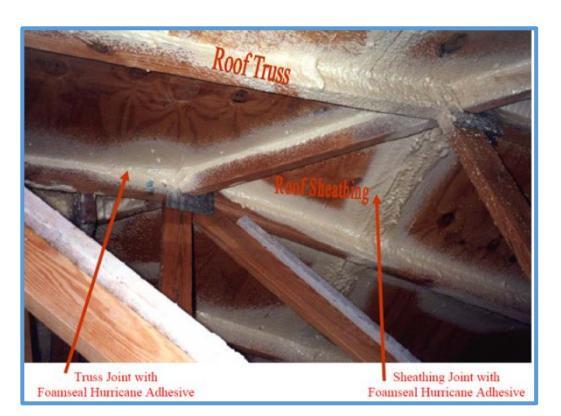
Becoming more common is a closed cell polyurethane foam used for insulation at the bottom side of roof sheathing. This bonds to the structural members as well as the roof sheathing and thus add to the structural integrity of the house. The closed cell also acts as a vapor barrier, so water and moisture are less likely to get inside the house. Closed cell foam is unharmed by water damage. This is a method recommended in the Florida Disaster Website and by FLASH. It is important to differentiate between closed cell foam and open cell foam. The open cell

foam has cells that are deliberately left open and thus is softer. Open cell foam can be used for insulation as well as soundproofing, but its rigidity is not the same as for closed cell foam. Again these are options to strengthen the roof if a homeowner cannot reroof.

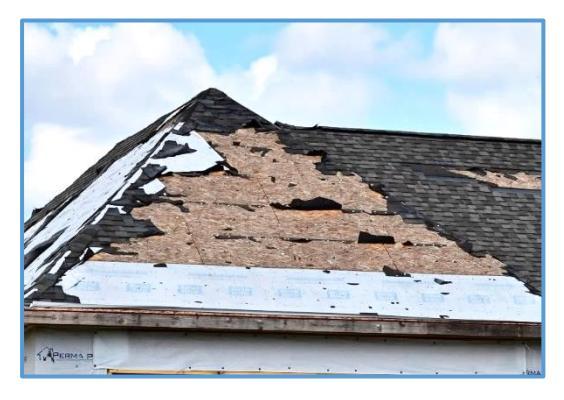
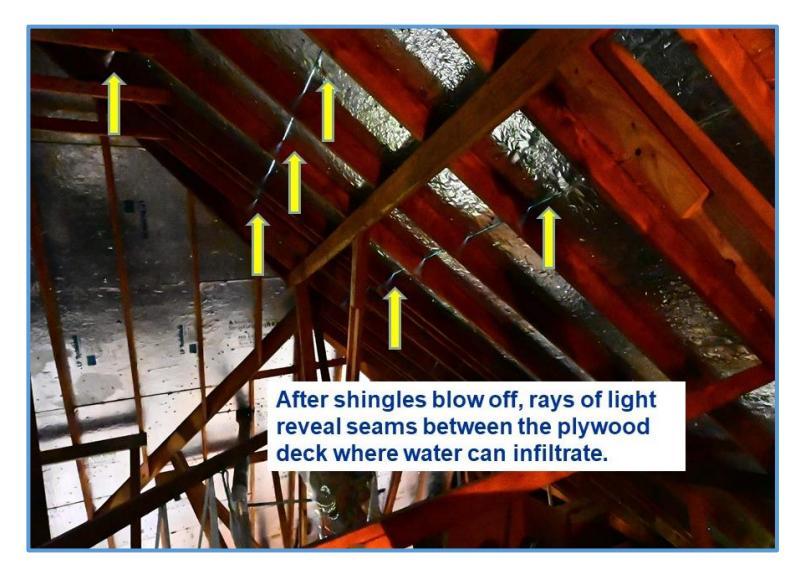
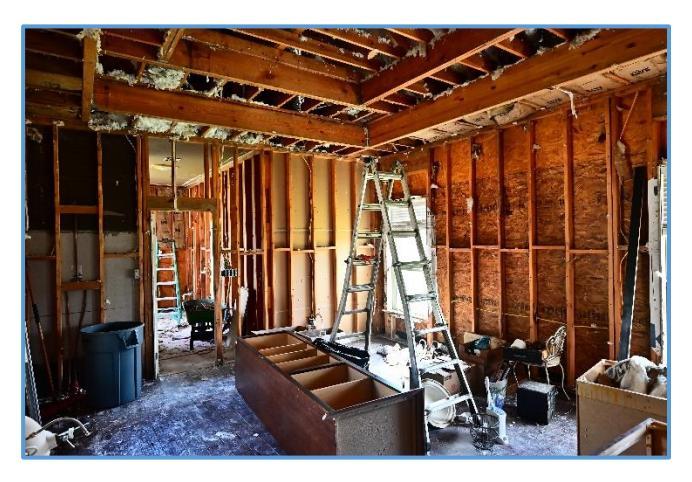
A common type of roof damage throughout Louisiana during Hurricane Ida was to have the roof coverings, such as shingles and the underlayment blow off (right). This exposes joints in the roof deck, seen in the picture. Water infiltration through the joints in the roof deck can lead to serious interior damage (below). Two measures to address this problem are to: 1) seal the roof deck (this section), and 2) make sure shingles are properly attached to the roof deck (next section).

Without the protection of shingles or an underlayment, the joints between the plywood panels are now exposed, which can lead to water infiltration. The picture at left shows a view from inside the attic where there are gaps in the plywood deck. The gaps are in by design to allow for expansion of the sheathing. However, with no covering, wind driven rain can make the gaps major leak points in the roof. This house had no structural damage, nor did the roof deck blow off the trusses. However, when the asphalt shingles and underlayment blew off the roof deck, water infiltrated through the joints between the plywood deck. This led to the collection of water on the ceiling, which spread to the edges of the house saturating the walls. Eventually the ceiling collapsed and the whole interior of the house had to be gutted.

Problems such as these can be avoided by sealing the roof deck, especially along hips and valleys, which is not a costly or time consuming retrofit or rebuild. There are three options to seal the roof deck (see FEMA Technical Fact Sheet 7.2 in Homebuilder's Guide to Coastal Construction (FEMA P-499) and Best Practices for Minimizing Wind and Water Infiltration Damage (FEMA Hurricane Michael Recovery Advisory 2) and the table below.

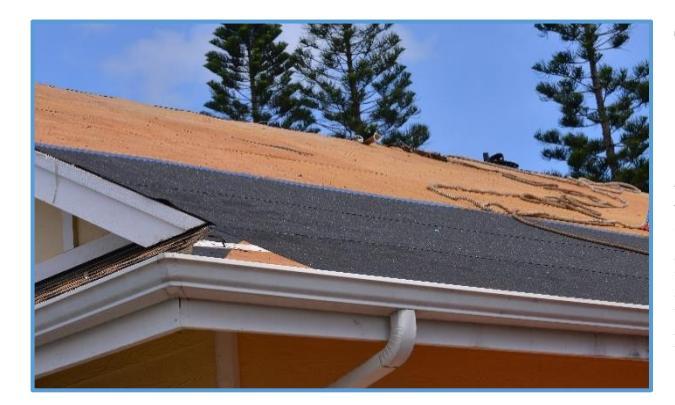
This is an example of installation of Option 1 sealing the entire roof deck with the selfadhering modified bitumen membrane (peel & stick). Option 1 is the costliest yet most protective as it will protect against leaks not only at the seams of plywood sheathing, but for the entire deck. This could be important for future penetrations of the roof, e.g., installation of solar. Consult with a licensed architect.

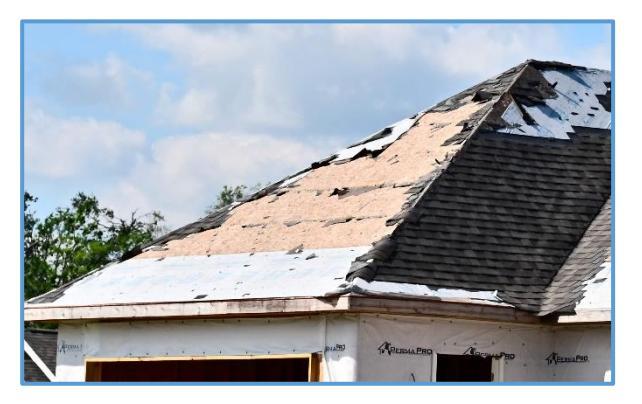
According to the St. Charles Tax Assessor, over 75% of the roofs in the Parish are asphalt shingle roofs. Roof damage was the most common type of damage in the Parish, as well as in the State, and the most common damage was roof shingles and underlayment blowing of the roof deck. As noted in the previous section, it is recommended that the roof deck be sealed. In addition, the shingles need to be strongly attached. The house in the photo to the right had asphalt shingles and underlayment blown off.

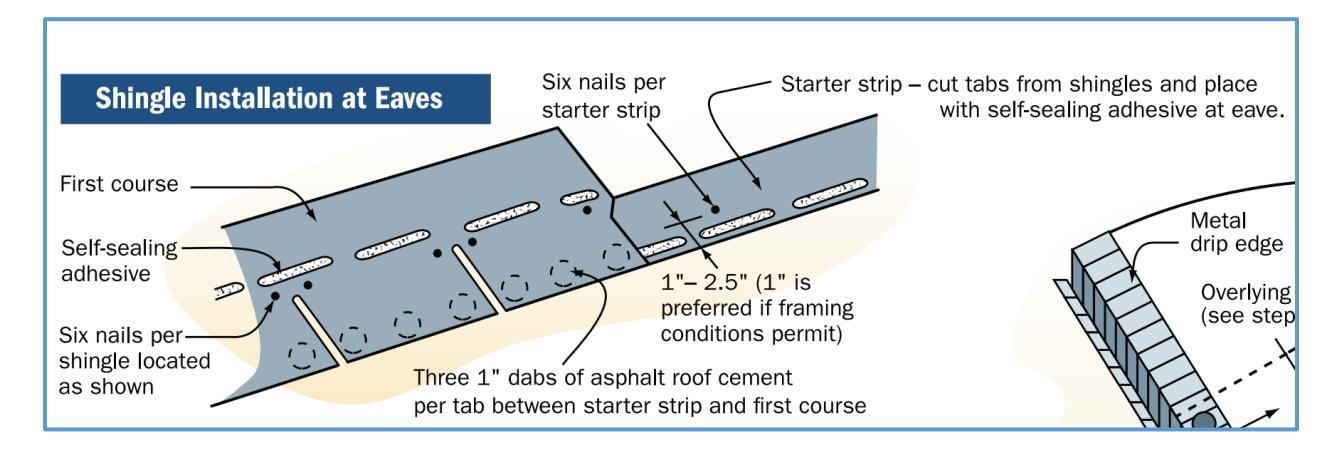
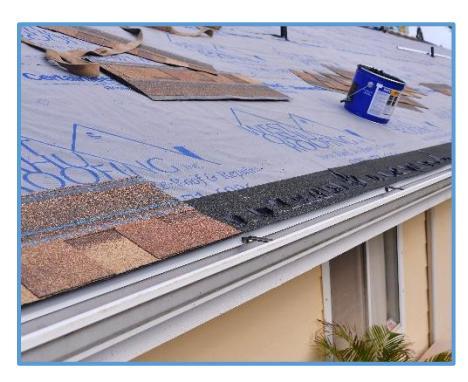
Example of installation with starter strip in black and dabs of asphalt cement between starter strip and first course in brown. This is to address the increased wind pressure at the vulnerable corners and edges of a house. This is where failure is often initiated. Refer to FEMA Technical Fact Sheet 7.3 for all details of installation, including for hips, ridges, eaves (edge parallel to the ground), rakes (edge running up to the ridge) and for all roof penetrations.

- 2) Use six nails per shingle. No staples. Stainless steel nails if building within 3,000 feet of saltwater. Nails should extend through the underside of the roof deck, or a minimum of ³/₄ inch into the roof deck.
- 3) Location of the nails is important. Follow the manufacturer's nail line or nail zone. See FEMA Recovery Advisory 2, June 2019 for Hurricane Michael.
- 4) Some manufacturers provide a 130 mph warranty with the use of starter strips placed at roof edges in the beginning of installation. Between the starter strip and first course add 1 inch dabs of asphalt roof cement.

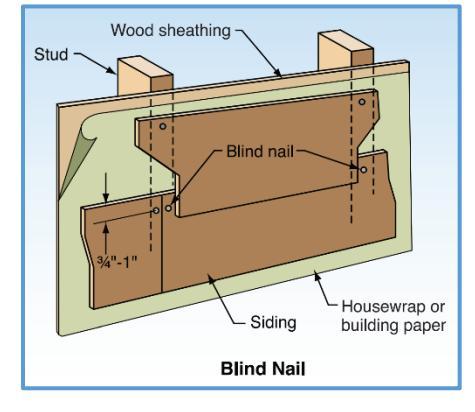
Another common type of failure is to have the fiber-cement siding blow of the house as shown to the right. While there is commonly a water barrier layer behind the siding, this can also blow off and lead to water infiltration. When attaching fiber-cement siding in high wind areas, it is important to face nail the siding and not rely on blind nailing.

From FEMA Technical Fact Sheet 5.3 – Blind nailing uses only one nail per sheet of siding per stud and the nail is hidden by the overlapping sheet. For face nailing, the siding is nailed from the top and bottom and is recommended in high wind areas. The telltale sign that the siding is

face nailed is that a nail will show at the bottom of the siding. This supposedly less esthetic characteristic does not warrant building weaker by using blind nailing techniques. Nails should also have an exterior grade coat.

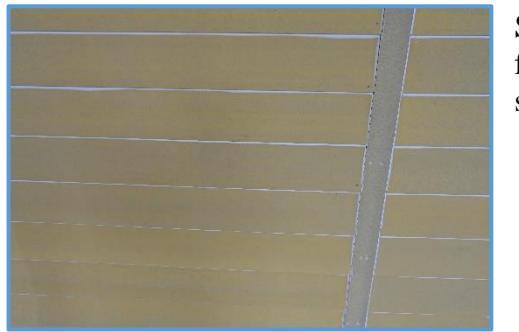
Some proactive builders attach the fiber cement using the face nailing technique and also caulk the seams of the siding for additional strength.

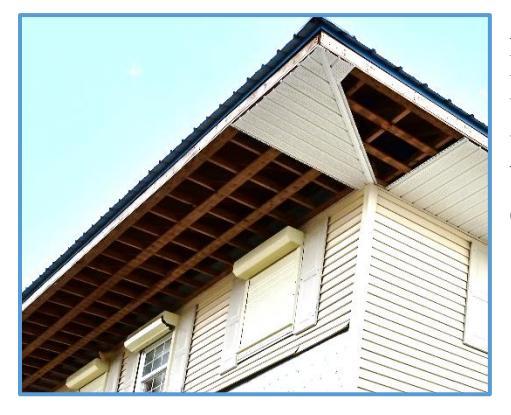
Another common type of damage experienced in many locations were soffits blowing off under eaves leading to water penetration in the house. The house to the left had windows protected with roll down shutters but the siding blew off to the bottom of the window and the soffits blew off at the top.

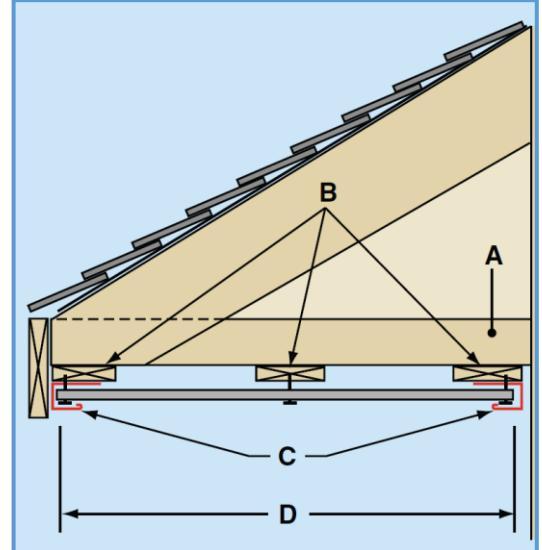
- A) Roof truss or rafter framing should extend across the bottom of the eaves, or be added to create structural support for the soffit. Alternatively attach the soffits to the undersides of angled rafters.
- B) Use nailing strips and add an intermediate strip if any spans are longer than 12" in high wind regions.
- C) A receiving channel or J-channel should cover the ends of soffit panels. Fasteners should be used through the nailing strip.
- D) The overall span of the soffit should not exceed manufacturer's specifications. Any intermediate attachments can be used.

In general, soffits should be fastened to the eave structure and should not be loose in the channels. Plywood or wood soffits are in general, adequately anchored to wood framing attached to the roof structure while vinyl and aluminum soffit panels to be installed in tracks are frequently poorly connected to the wall and fascia. Strength can be gained by installing screws that tie the soffit panels to both the fascia flashing and the wall channel. Technical Fact Sheet 7.5 also has guidance of using sealant to attach the wall channel to the wall followed by attaching the soffit to the wall channel.

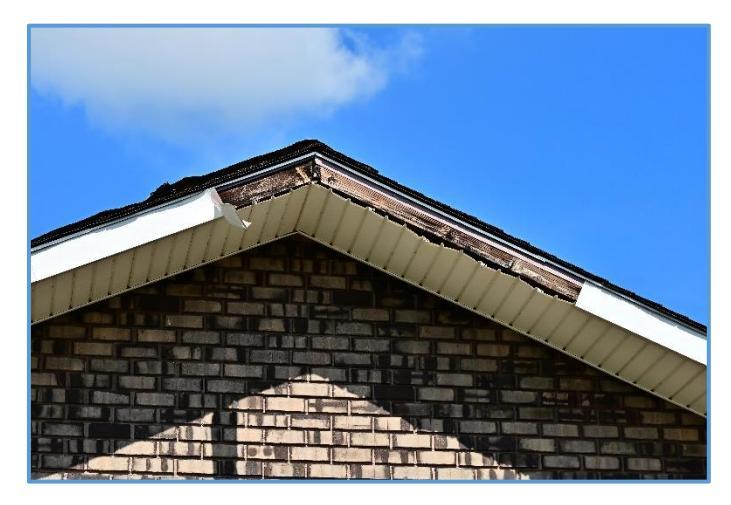
Very common is the loss of the fascia cover which exposes soffits to the direct entry of wind-driven rain. Aluminum fascia covers are usually tucked under the metal drip edge and face-nailed every few feet. More frequent nailing can strengthen this attachment but could lead to warping due to thermal expansion. Vinyl fascia covers are also available and when attached to a continuous strip of utility trim placed under the drip edge, can provide a more secure attachment without thermal movement.

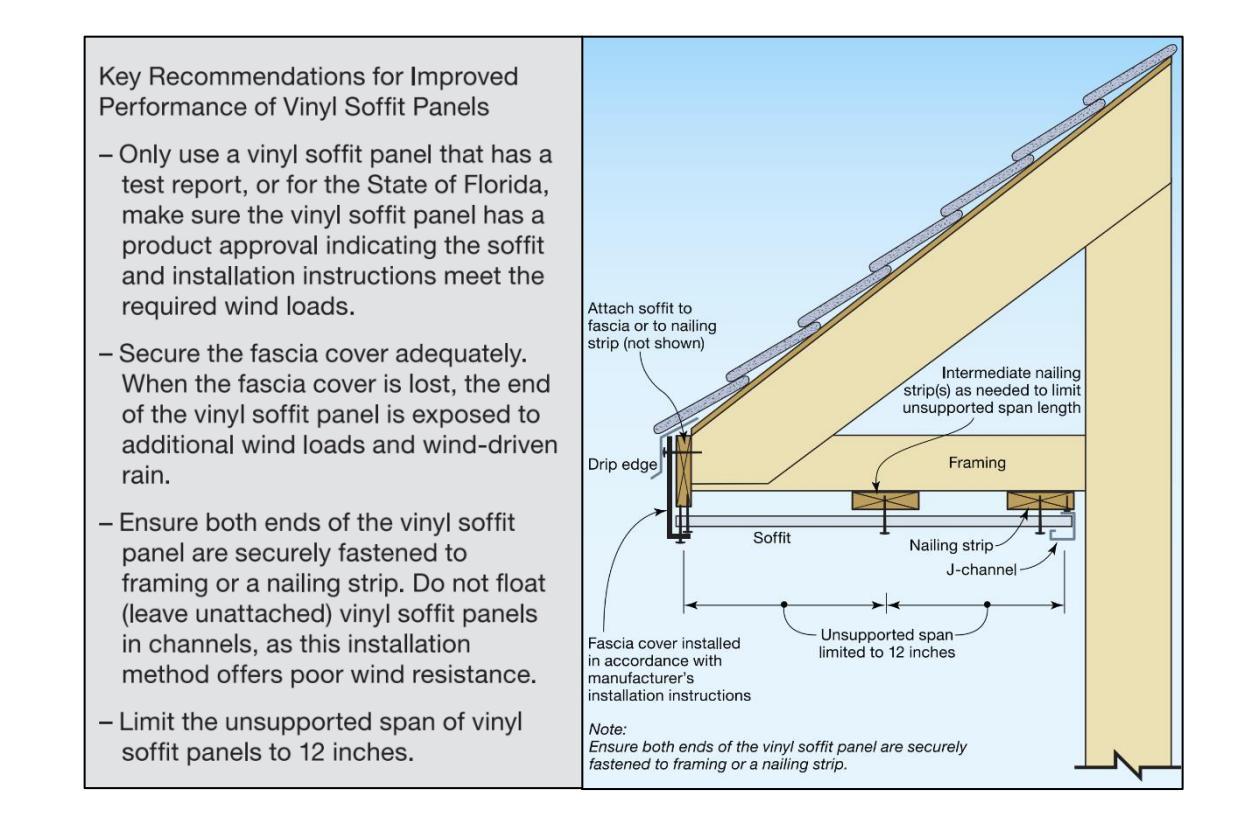
Below is additional guidance for improved vinyl soffit attachment from FEMA Recovery Advisory 2, June 2019 for Hurricane Michael. It can be seen the relationship of the metal drip edge, fascia, fascia cover and soffit. The fascia cover is nailed securely to the fascia and the soffit. An additional nailing strip may be required.

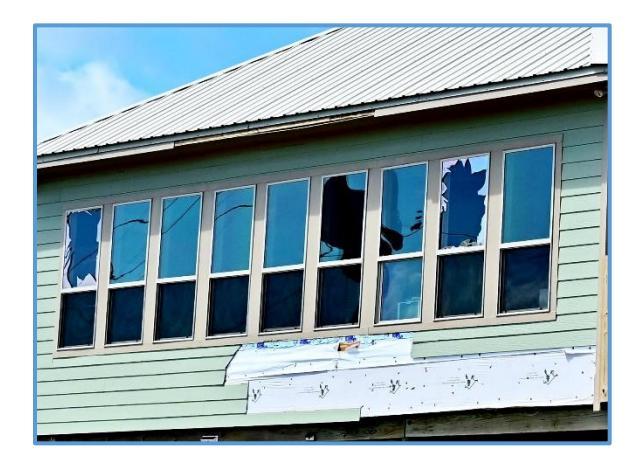
Protecting windows is one of the most important steps a Homeowner can take to prevent wind and water damage from a hurricane. If a window is broken, wind can enter a house and lead to internal pressurization which can significantly increase uplift pressure on a roof. For older homes, this may be enough to make the roof fly off. In addition, a broken window can lead to water infiltration in the house. For the photo at right, wind damage is shown by the broken windows and the damage of siding below the windows and blown off fascia to the top of the windows.

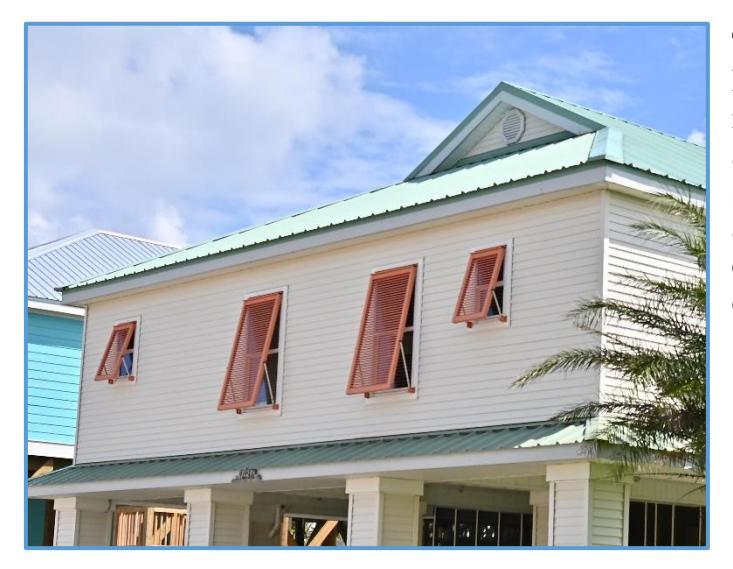
To the left is a house protected with Bahama shutters. This is a common method of protection in many high wind areas. During normal conditions, the shutters are propped open to allow light and air. During a storm they are quickly closed to protect against wind borne debris.

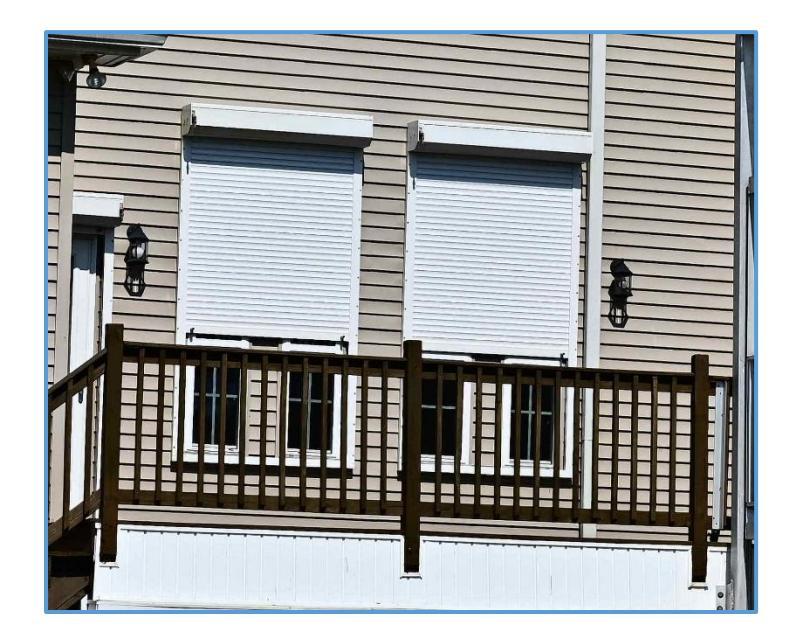
To the right is a house protected by roll down shutters. This is also an effective means of window protection, but more expensive. Opening and closing can be done electrically, or if the power is out, manually.

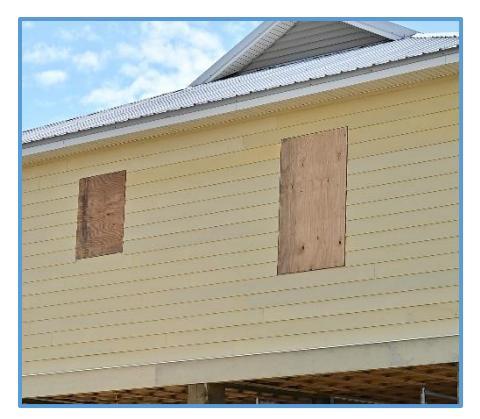
The least expensive method of window protection is plywood, but this needs to be prepared before an event and can be heavy. For any covering providing window protection, the standard is to pass the large missile tests ASTM E1996 and ASTM E1886 for windows within 30 feet of grade. The small missile test is allowed for openings more than 30 to 60 feet above grade. The IBC and IRC allow plywood as an exception with 7/16 inch panels that do not span more than 8 feet. 7/16 plywood will not meet the large missile tests, but 5/8 will and thus is recommended by IBHS, unless the homeowner cannot handle the weight.

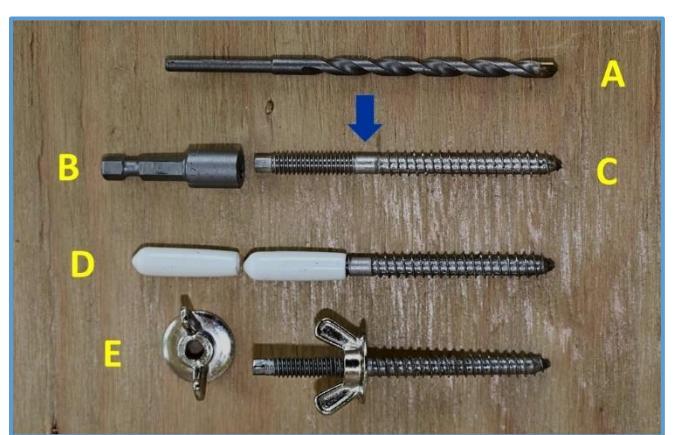
New products on the market that can facilitate window protection include polycarbonate panels. These panels are just as strong as plywood but lighter. In addition, Storm Panel Screws by Simpson Strong-Tie can facilitate deployment of plywood or polycarbonate panels. The screws come with A - a drill bit to pre-drill the screw into wood or concrete; B - hex driver to fasten the screw into the material to the interesection of the course and fine threads (blue arrow),

C – Storm Panel Screw; D – white caps which are in place during normal conditions; and E – wing nuts which attach the panel to the screw before a storm event.
